## Root cause analysis and Resolution of a brass extrusion mandrel failure

Mandrels made of DIN 1.2367 (AISI H10) hot-work tool steel are critical components in the hot extrusion of seamless C27000/C38500 brass tubes. In this case, after a change in the tooling supplier, mandrel life dropped to ~ 10% of the historical benchmark, with premature brittle fractures occurring during routine production. A comprehensive failure investigation was performed combining chemical composition verification (ASTM E415), tensile testing (ASTM E8), hardness mapping (ASTM E18), surface roughness measurements, Charpy impact testing (ASTM E23), fractographic examination of fracture surfaces, and finite-element simulations of the extrusion stage. The steel chemistry complied with DIN 1.2367; however, the hardness in the upper region exceeded the specified range, consistent with reduced toughness. Fractography showed crack initiation at the inner surface of the cooling channel, where drilling-induced surface damage (e.g., high roughness, burrs, and potential microcracking) served as critical stress concentrators within a region exhibiting hardness gradients. FEM confirmed that this bore is subjected to

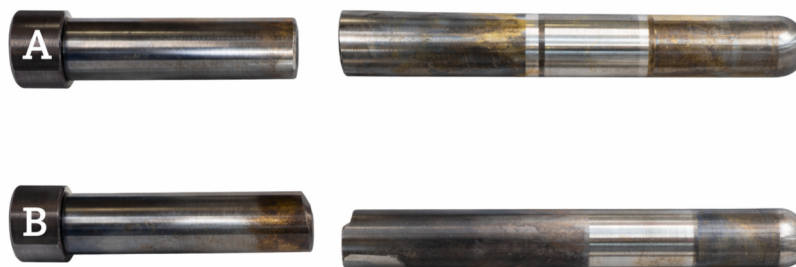
Following a change in the tooling supplier, a significant reduction in the service life of mandrels used for the hot extrusion of seamless tubes was observed. Mandrels from the new batches exhibited brittle fracture during forming, failing to meet the previously established durability criterion (see Fig. 1).

Fig. 1. Examples of brass-tube extrusion mandrels failed by brittle fracture.

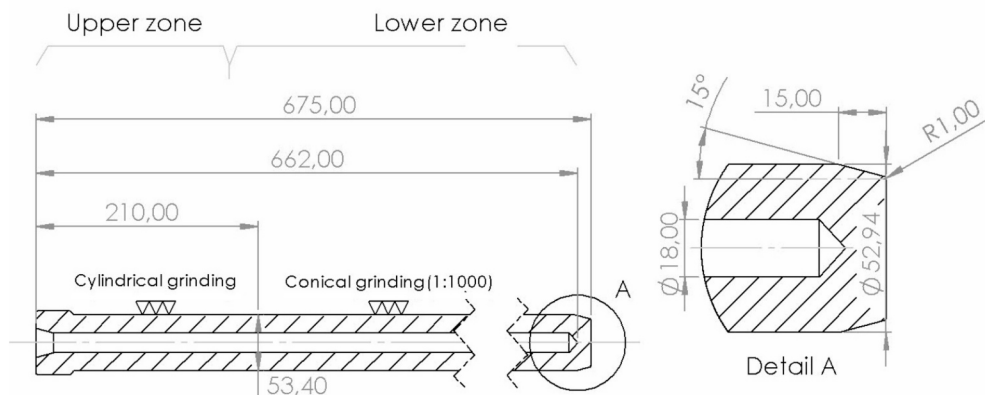
shown in Fig. 2. In the two representative cases analyzed (mandrels A and B), the fracture surface was located at  $234 \pm 8$  mm from the mandrel support face. Although such deviations can fall within the expected range of fatigue scatter, evidence suggests these failures were driven by surface topography rather than bulk material defects. Localized surface roughness acted as a stress concentrator, increasing the probability of crack initiation. Subsequent improvements to the surface finish significantly mitigated the fatigue risk, confirming that surface quality is a critical parameter for operational life. Finally, billets are cylindrical, and during the first stage of extrusion, the mandrel pierces the billet through the thickness to establish the internal tube diameter.

Fig. 2. Manufacturing drawing of the hot brass-tube extrusion mandrel (DIN 1.2367).

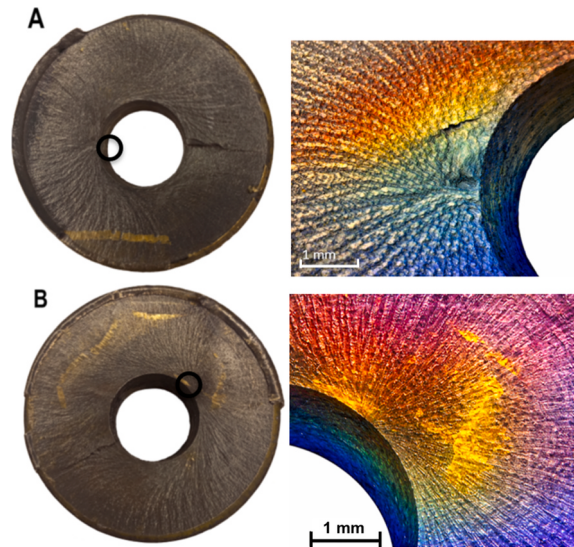
**Fig. 3.** Fracture surfaces of mandrels A and B: circles indicate crack initiation sites, with high-magnification insets showing characteristic topographic details.

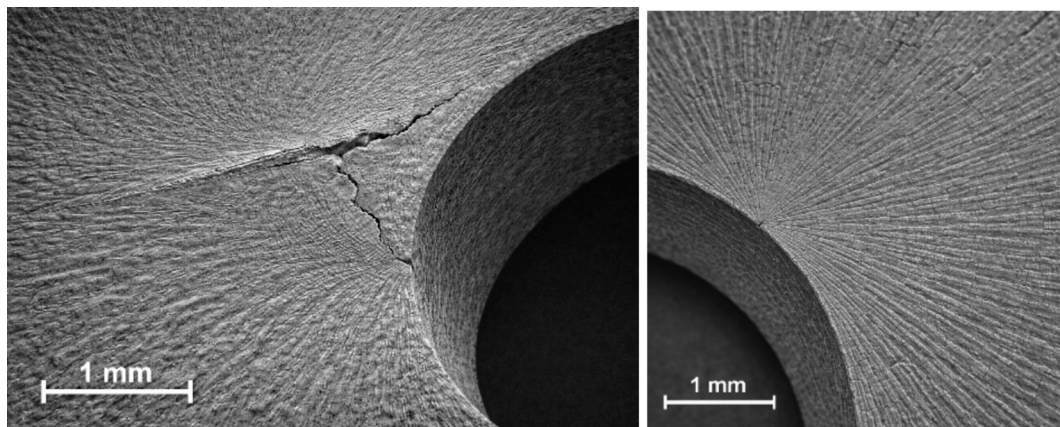
Fig. 4 shows a magnified view of the initial crack area, enhanced to highlight the failure mechanisms. The analysis focuses specifically on the initiation of microcracks, which appear to originate from localized surface points or zones. The irradiation shape in Fig. 4 right is clear. There is no any Herzian contact here, defects were located stating in surface defects due the lack of smoothness.

Following crack penetration, small-scale spalling occurs. As illustrated in Fig. 4 left, the process begins at the origin and leads to subsequent shearing under surface crack failure. Both cases demonstrate consistent morphological features. In Fig. 4 right, a hand fan pattern typical of surface cracks is clearly defined. There is not hertzian contact in those points, so undersurface shear stress cannot be the cause.

**Fig. 4.** A more detailed examination of cracked stating areas: left) mandrel A, and right) mandrel B.

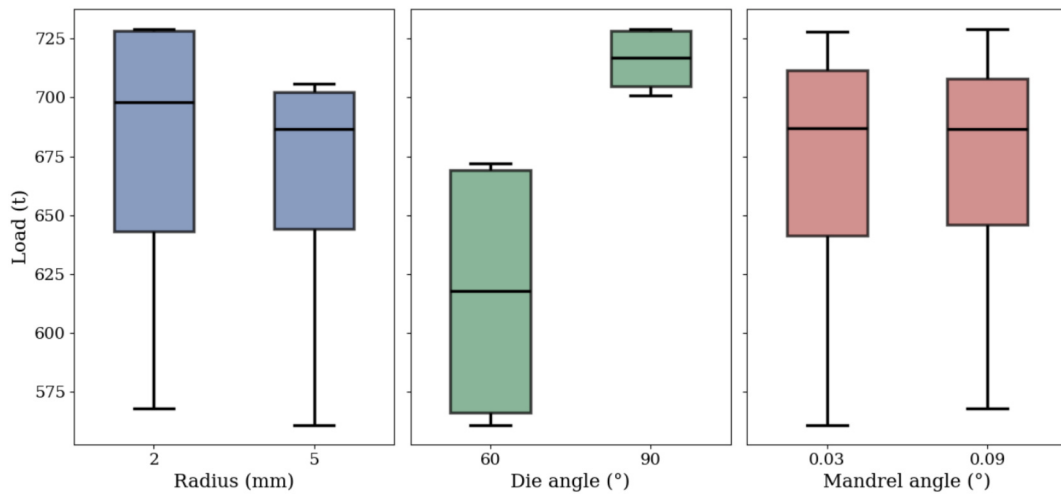
The extrusion loads predicted by the FEM simulations for all DOE combinations are summarized in Fig. 5. The results confirm that the configuration currently implemented in the plant—characterized by a die angle of  $90^\circ$  and a small die radius—yields among the

highest extrusion loads, consistently exceeding 700 t. The boxplots clearly identify the die angle as the dominant factor affecting the process; transitioning from a 90° to a 60° configuration results in a substantial reduction in load, with the 60° setup yielding the lowest recorded values, often falling below 625 t. In contrast, variations in die radius (from 2 to 5 mm) and mandrel angle (from 0.03 to 0.09) exhibit a negligible influence on the extrusion load, as the median values remain nearly constant across their respective parameter ranges.

Fig. 5. Boxplots of extrusion load vs. DOE factors and levels.

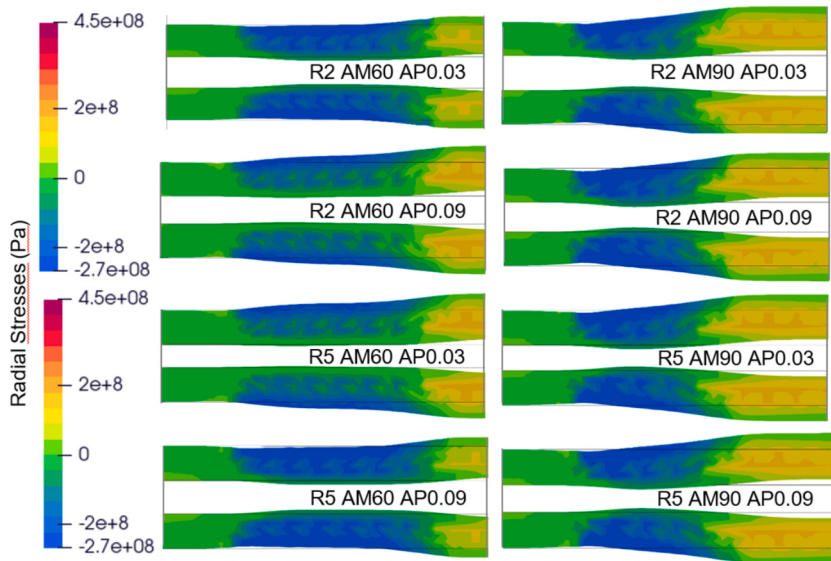
The radial stress distributions illustrated in Fig. 6 characterize the internal mechanical state of the mandrel under various geometric

configurations. Across all eight simulated conditions, combining fillet radii ( $R_2, R_5$ ), mandrel angles (AM60, AM90), and aperture sizes (AP0.03, AP0.09), the results indicate low-magnitude compressive stresses in the vicinity of the cooling-channel bore. These compressive values remain relatively stable, typically ranging between  $-2.0 \times 10^{-8}$  and  $-2.7 \times 10^{-8}$  Pa. Notably, the figure demonstrates minimal sensitivity to geometric variations; the blue-toned compressive zones consistently localize within the central regions regardless of changes in taper angle or aperture depth. This stability suggests that radial loading is dominated by the internal pressure of the extrusion process rather than the external mandrel profile. In contrast, the axial stress distributions in Fig. 6 reveal pronounced tensile stresses concentrated at the cooling-channel bore, which increase significantly with the larger die angle (AM90). These tensile stresses are particularly critical because the mandrel operates at elevated temperatures, where hot-work tool steels such as H11 undergo substantial reductions in mechanical strength [27].

Fig. 6. FEM radial stress maps for the DOE combinations.

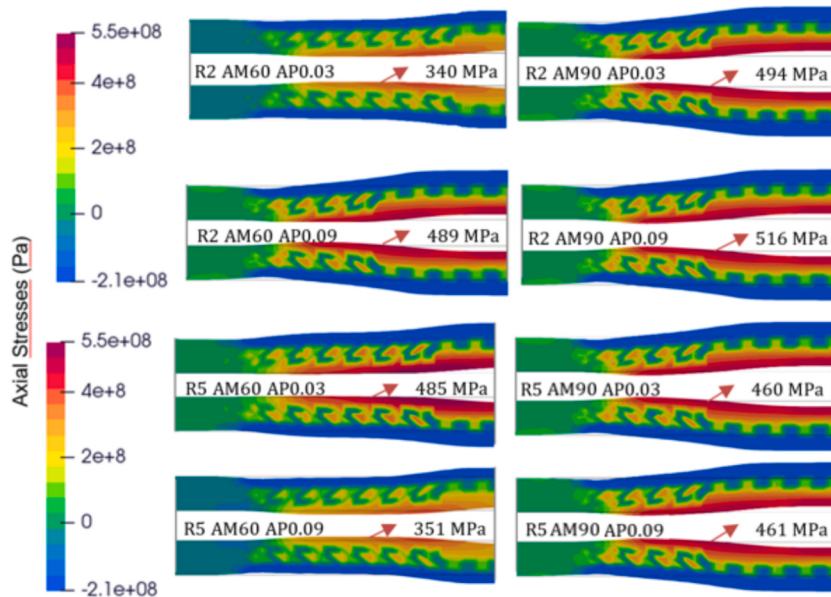
Fig. 7. FEM axial stress maps and their maximums for the DOE combinations.

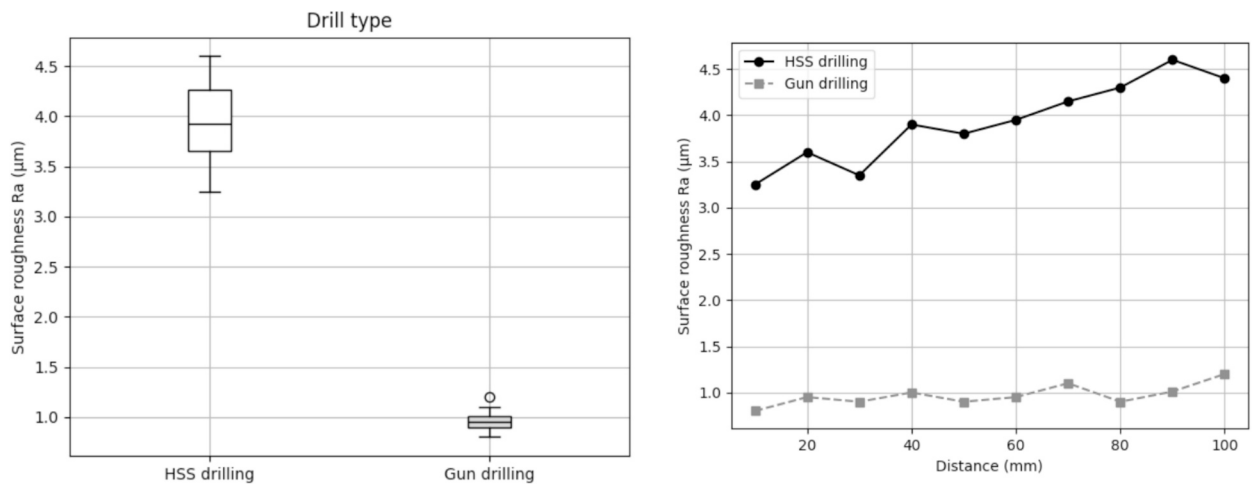
Fig. 8 shows that gun drilling produced significantly lower roughness values and a markedly more uniform surface finish along the drilled length. In contrast, HSS drilling produced higher roughness levels and substantially greater scatter, with a clear tendency for roughness to increase with drilling depth. Extrapolation of the roughness–depth trend observed for HSS drilling suggests that, at the fracture location ( $234 \pm 8$  mm from the entry), the surface roughness could reach values of approximately  $R_a \approx 6 \mu\text{m}$ . Such roughness levels are expected to act as pronounced stress concentrators, thereby exacerbating the tensile stress state identified at the cooling-channel bore and promoting crack initiation.

Fig. 8. Ra values obtained with the two drilling processes (HSS twist drilling vs. gun drilling).

The corrective action implemented replaced the conventional high-speed steel twist drilling process with deep-hole gun drilling using a carbide-tipped drill (grade H10, submicrograin structure with a 10% Co binder). This class of tools is well known for producing high-quality deep holes with low, consistent surface roughness, typically  $R_a = 0.80\text{--}1.25 \mu\text{m}$  [29], which is particularly advantageous for fatigue- and fracture-critical components. Comparative trials were conducted between the previously used multi-pass HSS (M2) drilling process and the proposed gun drilling approach. Internal surface roughness was measured over 100 mm of the hole length to assess both average roughness and depth variability. From a mechanical perspective, the localized grooves and roughness associated with conventional drilling act as micro-notches, generating significant stress concentrations. While such concentrations can theoretically increase local stresses by a factor of 4 to 10, these values are difficult to measure experimentally. Furthermore, current computational models face limitations in accounting for the stochastic effects of small-scale microroughness. In this context, surface roughness acts as a primary accelerator of crack initiation and early growth. Notably, as shown in the axial stress, the macroscopic curvature of the cooling-channel bore is not sufficiently sharp to justify these premature failures; therefore, the microscopic surface topology is the dominant driver of the increased stress state.

Accordingly, the drilling process was permanently modified to carbide-tipped gun drilling. In parallel, the region exhibiting differential mechanical properties associated with the upper–lower transition of the mandrel was eliminated, further reducing the likelihood of localized stress amplification. Following the implementation of these corrective actions and the reintroduction of the modified mandrels into production, mandrel service life was restored to its historical level of approximately 250 pressings, thereby confirming the effectiveness of the measures adopted.
